# EDUCATIONAL FACILITY PLAN

COLLEGE PLACE PUBLIC SCHOOLS  
COLLEGE PLACE, WASHINGTON

MGT of America, Inc.  
711 Capitol Way, Ste. 608  
Olympia, WA 98502

January 6, 2005

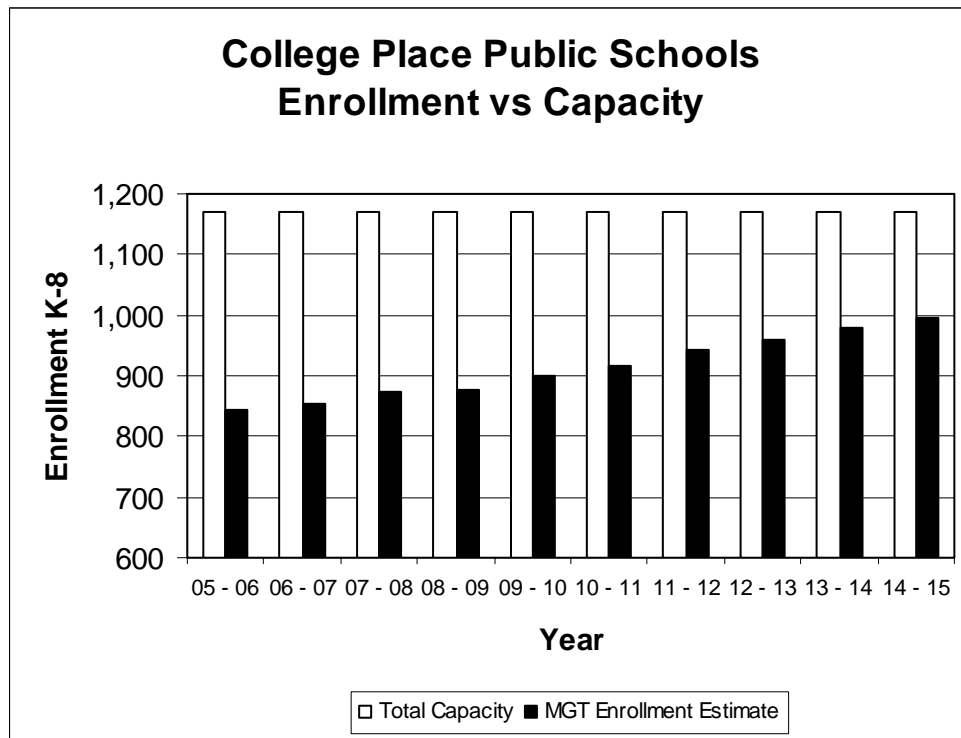
**EXHIBIT 3-12  
ENROLLMENT VS. CAPACITY (K-8)**

The total maximum PreK-6 elementary capacity of 796 easily exceeds the total projected enrollment of 561. The same is true of the middle school with a capacity of 373 and an enrollment of 287 students. At no time in the 10 year enrollment projection is the enrollment for any grade configuration expected to exceed capacity. Exhibit 3-12 provides a graphic representation of the relationship between capacity and enrollment for the coming decade for College Place Public Schools.
